Study of Source/Capture of Airborne Chloramines

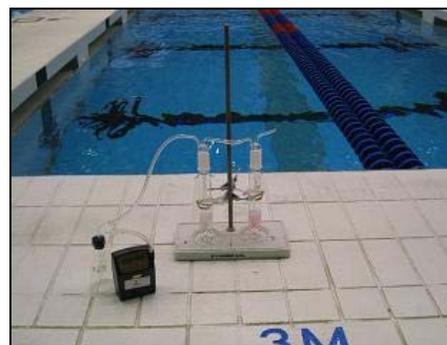
In addition, one observation was made in the pool gutter itself to give a representative view of the chloramine concentration at the water’s surface. This proved to be rather difficult due to the splashing of swimmers as they made turns in the vicinity of the testing apparatus.

Samples were collected hourly at the pool deck level and on a table 40 inches above deck level. Both apparatus were located 54 inches from the pool gutter.

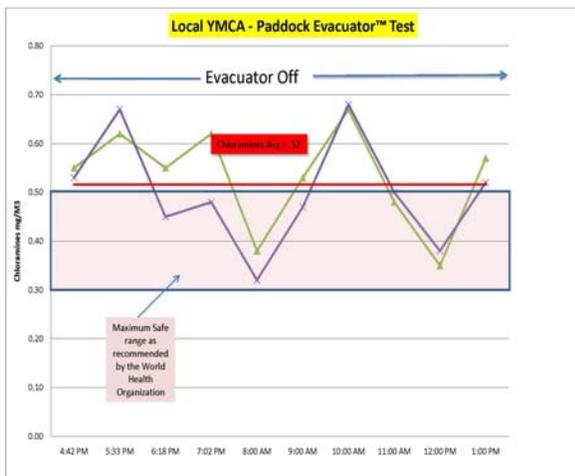
Chart 1 shows the observed levels of airborne chloramines in mg/m³ in the air around the pool deck during a normal period of pool activity.

The average level of airborne chloramines observed was .52 mg/m³ with a minimum of .32 mg/m³ and a maximum of .67mg/m³. Chloramines measured in the gutter were .68mg/m³. The World Health Organization recognizes .30 mg/m³ as the minimum “detectable” concentration and .50 mg/m³ as the maximum comfortable concentration before irritation symptoms are documented.

If baseline data and test period data are compared, one can readily conclude that the Evacuator system effectively removed a majority of airborne chloramines during the testing period. Test results from the pool gutter confirm that the chloramines at the water surface were similar (.68 and .66mg/m³) during the two test periods.

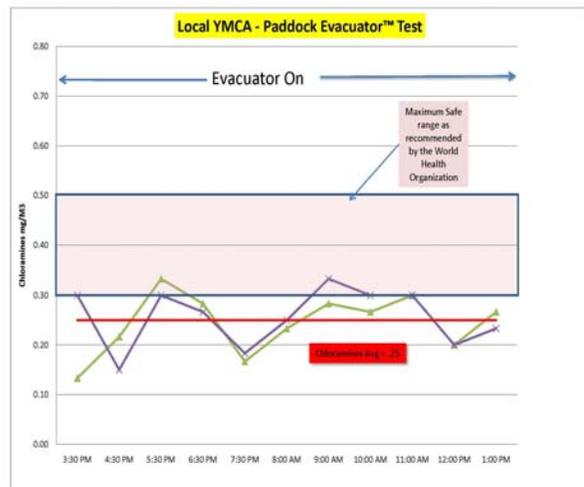
After baseline data were collected, the Paddock Evacuator™ system was activated and initial adjustments made. Hourly data samples were again collected. Chart 2 shows the observed levels of airborne chloramines in mg/m³ after turning on the Evacuator system.

The average level of airborne chloramines observed was .25 mg/m³ with a minimum of .13mg/m³ and a maximum of .33mg/m³. Chloramines measured at the gutter were .66mg/m³.
